# Cranes Lift Aircraft Firm's Productivity

## Case Study Overview

- **Business:** Aircraft maintenance
- **Product type:** Free Standing Work Station Bridge Crane with Aluminum Bridges
- **Lifting Device:** Electric Chain Hoist

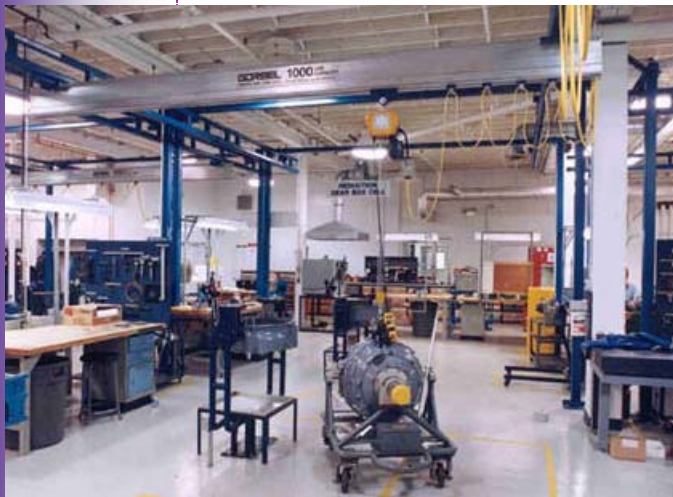
To resolve the problem of product damage and employee safety, the company chose three 1,000 lb. free standing work station bridge cranes, all with aluminum bridges on steel enclosed track runways. The aluminum bridge is 40% lighter than a comparable enclosed track steel bridge and is 300% lighter than an I-beam crane system. Less than 5 lbs. of force is necessary to position the loads. An electric chain hoist is used for lifting.
